TURBOMACHINERY SYMPOSIUM

CASE STUDY

‘BALANCE INSTABILITY AND VIBRATION ON A 6 MW INDUCTION MOTOR ROTOR’

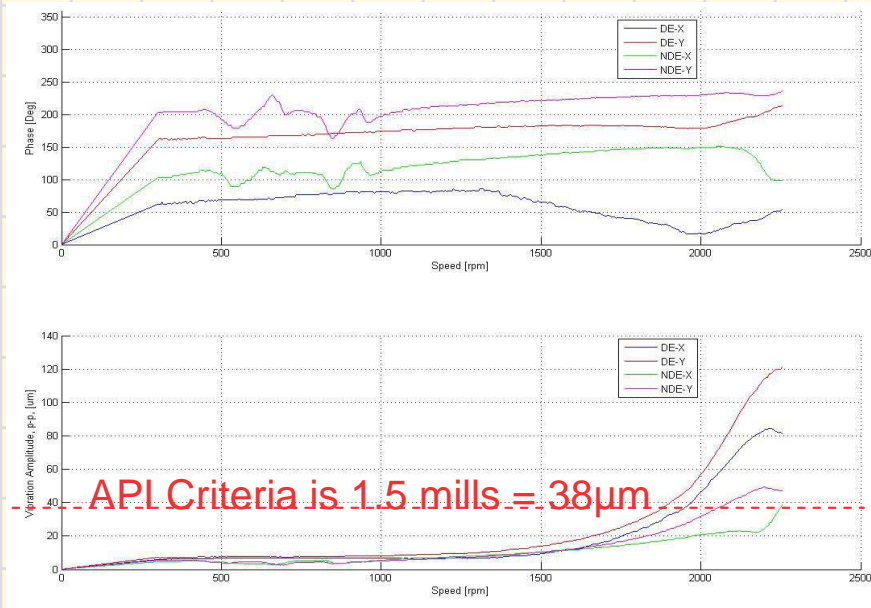
Bearing Vibrations during
Overspeed Test

- High vibration levels during over-speed test
- Vibrations above normal for the machine type at running speed (1800 rpm)
- High vibrations during over-speed test led to bearing failure

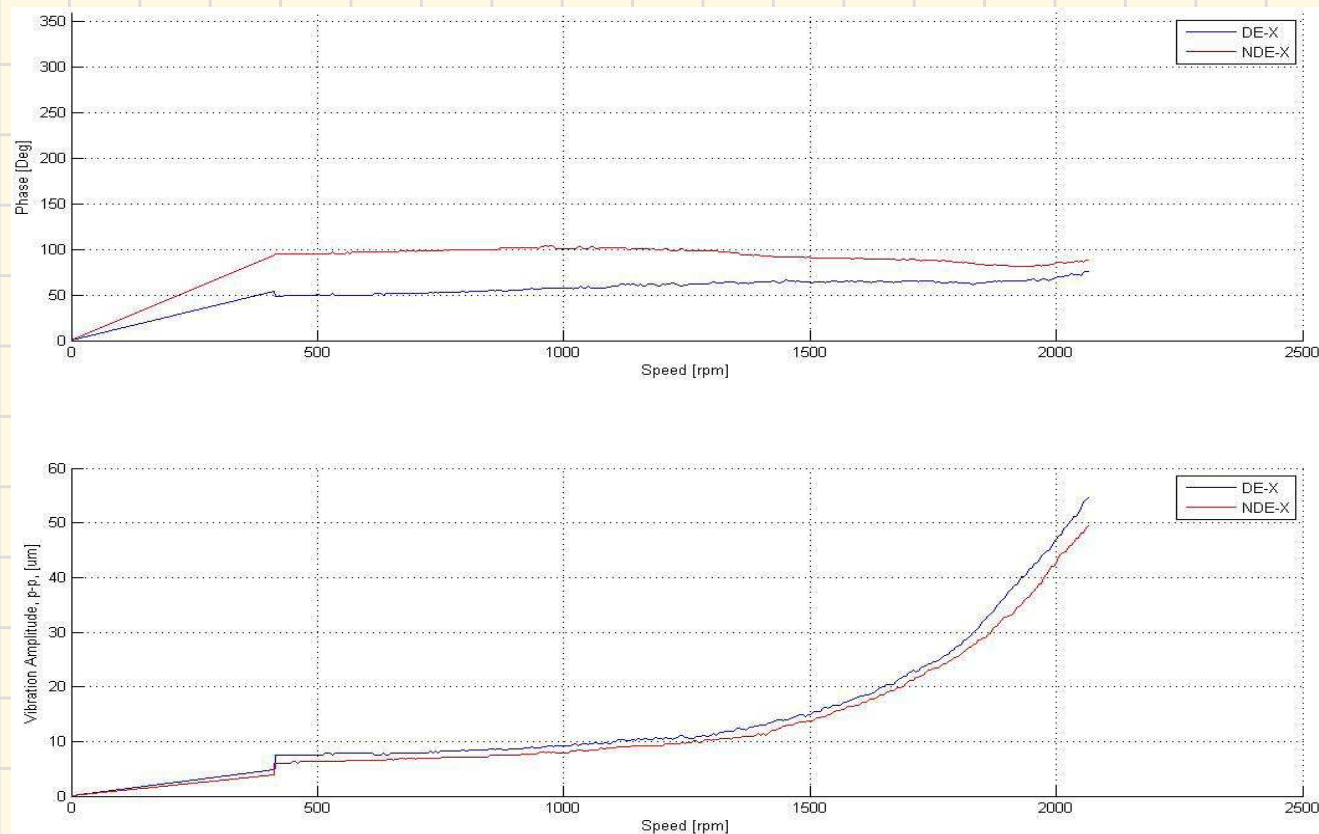
Residual Un-Balance After Re-Balancing

- Assumption:
 - The vibrations are caused by unbalance in the rotor due to initial settlement during the first heat run and/or over speed test
- Decisions
 - Residual Unbalance Check → Re-Balance at Low Speed (1000 rpm) → New Test
- Result
 - Vibrations still not meeting the requirements

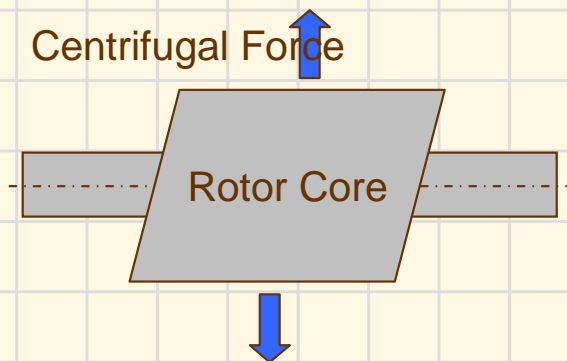
Rotor core measurements

- Measurements showed that individual sheets in the lamination were skewed/buckled
- Centrifugal force acts to 'straighten' the sheet metal plates which could lead to changed balancing state

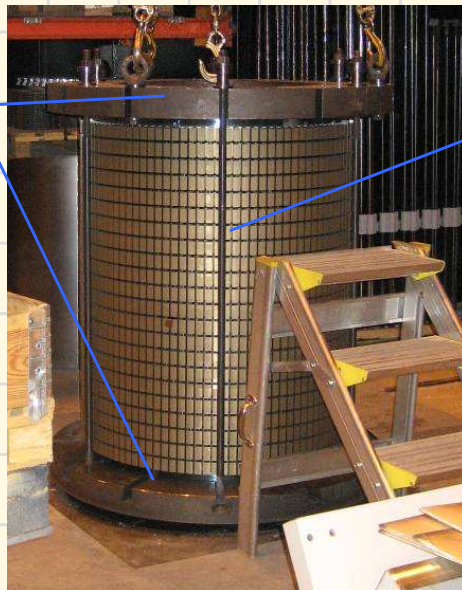
Rotor Core Compression

- Attempt to recompress the rotor core lamination to make it perpendicular to the rotor centre line
- Result:
 - Improved vibration but still not meeting requirement, balancing state still changes with speed
- Conclusion:
 - Recompression not working due to high friction between rotor core and spider shaft

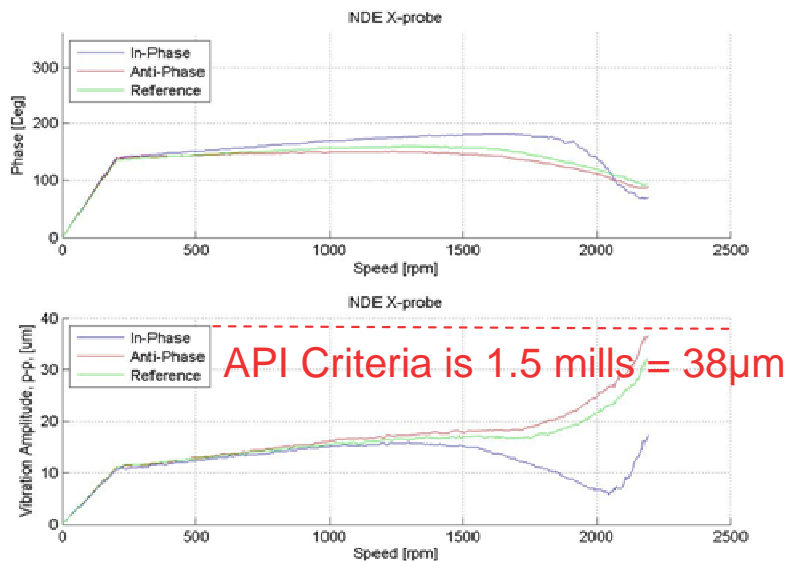
NDE X-direction

- Solution for the problem:
 - Balancing of rotor at full speed (settling effects within balancing)
- Results
 - After full speed balancing vibration levels are within required limits
- Forced unbalance tests for final verification
